Summers, L. & Maddrell, R. J. 1978

Barton-on-Sea: Development of an Alternative Approach to Coast Protection.

Paper presented to the Geological Society Engineering Group regional meeting at Southampton University, September 1978.

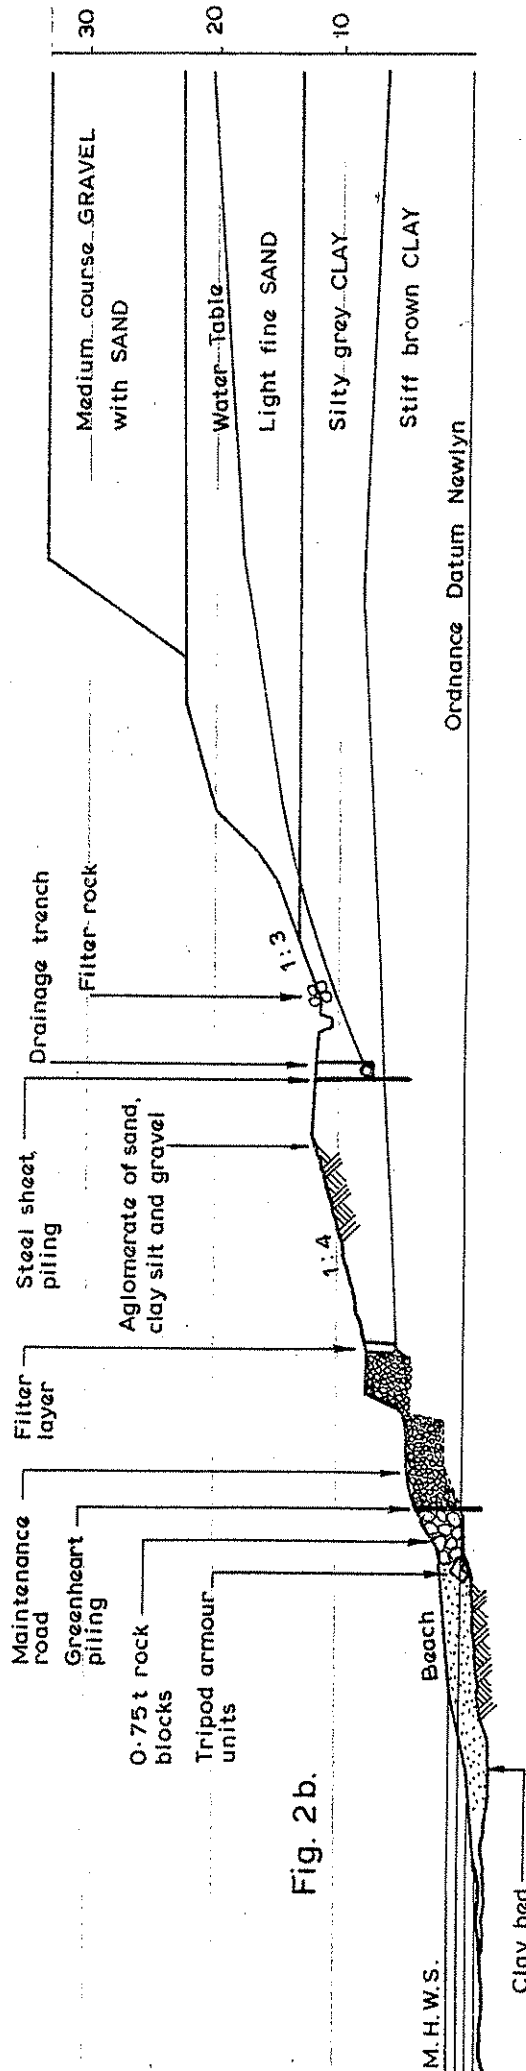
FIGURE 2. CROSS SECTIONS OF FORESHORE AT BARTON-ON-SEA a) 1960 b) 1978

The landward topography at Barton consists of a fairly level plateau at an average height of about 35 m above Ordnance Datum (approximately Mean Sea Level), fronted by a steep cliff below which lies an undercliff area of broken ground extending for about 70 m out to the foreshore. The toe of the natural undercliff is formed of a clay bank, exposed to wave action in storms and at high tides, then several flat terraces which tend to pond water, with intermediate clay banks and, beyond, a water-logged broken silty-sandy stretch of ground rising at a slope of about 1 in 3 to the foot of a steep cliff of terrace gravels. Figure 1 shows a plan of Christchurch Bay and Figure 2 (a) is a typical cross-section of the cliff and foreshore as it was in 1960.

Comparison of previous editions of the Ordnance Survey maps showed that erosion of the foreshore, followed by consequent cliff falls, although irregular and at times reversed by accumulation of beach material, had averaged approximately 1 m per annum since 1871. At the western end of the Borough the clay cliff on the foreshore was under intermittent attack by storm waves unimpeded by the narrow shingle beach. Towards Beckton Bunny in the east pressure of groundwater was causing the semi-permeable silts to flow seaward followed by a series of repeated collapses of the upper gravel cliff. Between these two extremities lay the central green of the township, with cliff failures having already claimed a number of buildings and others being put at steadily increasing risk of having to be abandoned as dangerous.

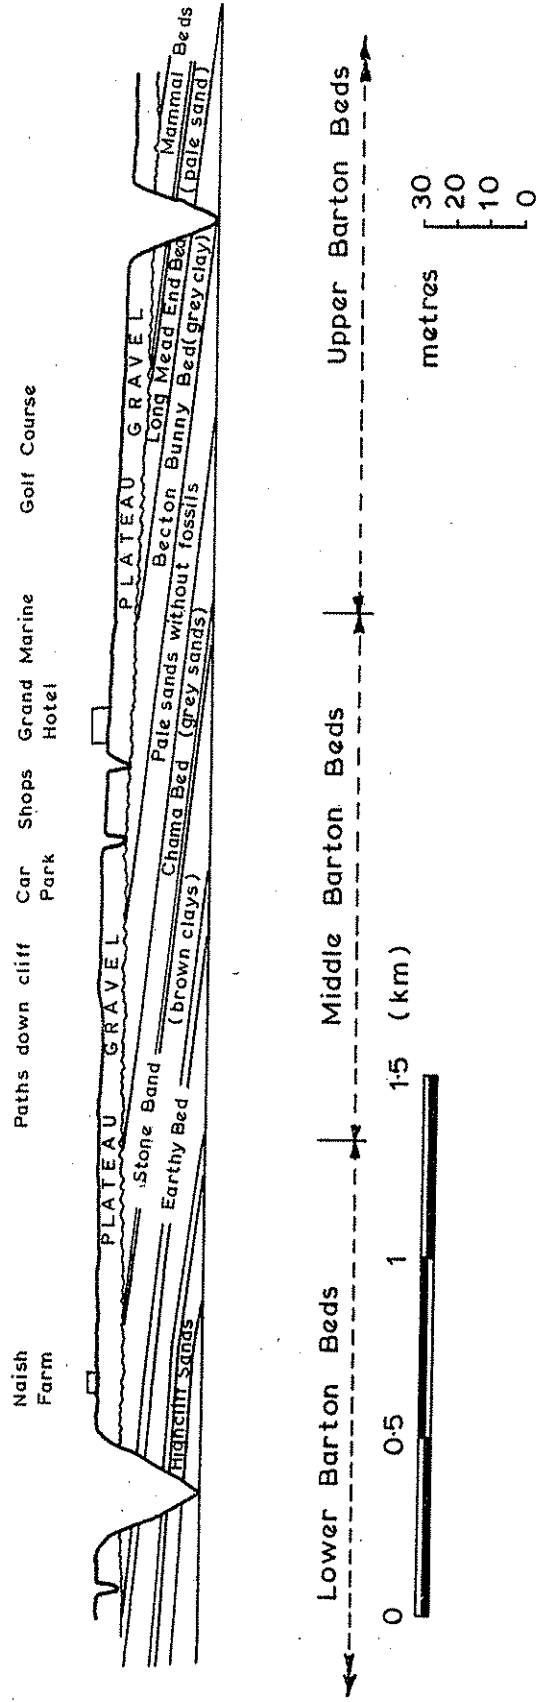
FIGURE 3. GEOLOGICAL ELEVATION THROUGH CLIFF AT BARTON

The geological structure of the ground, shown in Figure 3, is one in which a capping of open plateau gravel rests unconformably on semi-permeable silty sands of the Upper Barton Beds which in turn overlies

the impermeable silty clays of the Middle Barton Beds. The beds dip towards the east at a variable slope, but averaging 1 in 80. Thus the top of the undisturbed Middle Barton clay stands at about 30 m above Ordnance Datum near the western Barton boundary on the line of the Walkford Brook in Chewton Bunny and drops to about 15 m below Ordnance Datum 3.5 km to the east, at the point where the stream in Beckton Bunny flows into the sea.

Groundwater in the Barton sands is perched above the clay and although it generally drains inland following the strata dip, it does also emerge as springs on the undercliff. The waterlogged material resulting from this flow causes clay slumps and mud flows towards the sea. This reduces support for the gravel cliff face and results in periodic massive cliff falls which gradually subside to become mixed with the flows. This material on reaching the foreshore is easily distributed by waves, the finest particles being carried offshore, the sand and fine gravels oscillating in and out of the tidal range as littoral drift, and only the very coarse material remains on the beach throughout the winter.

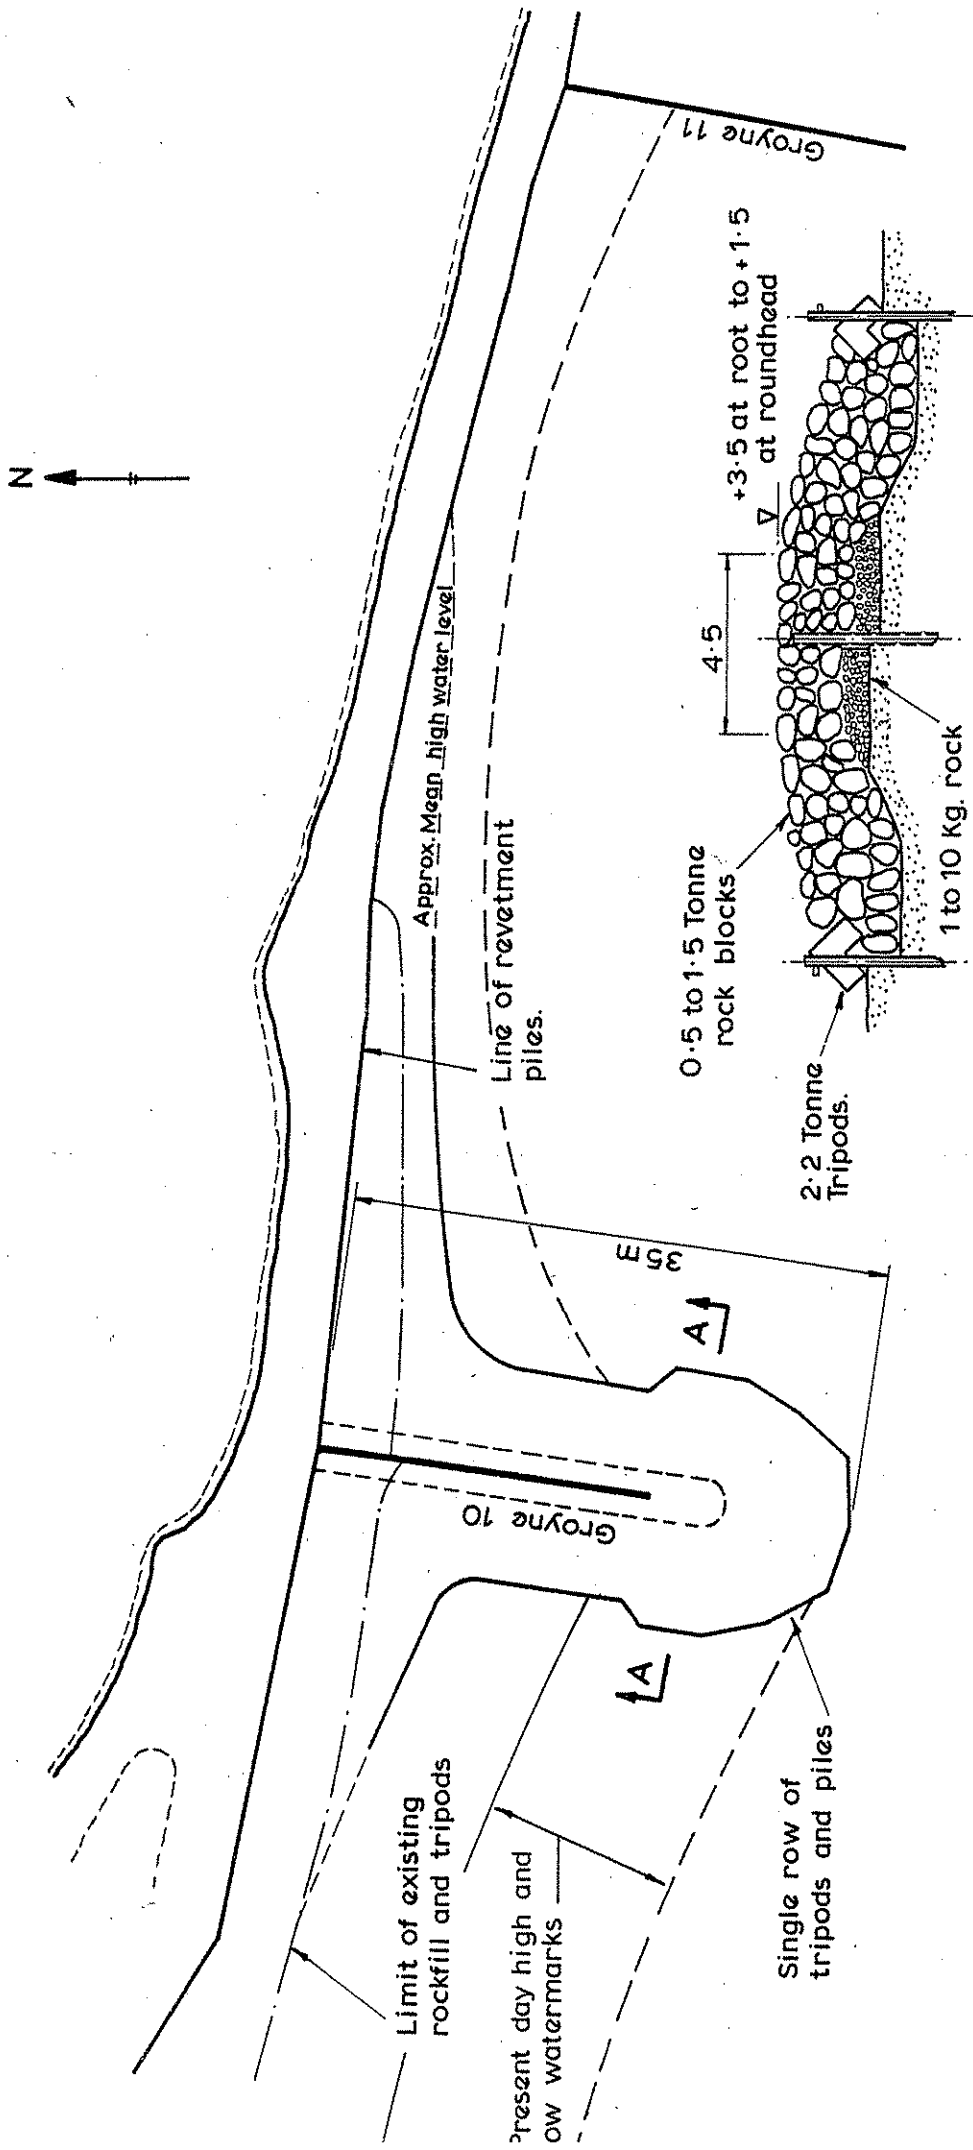
FIGURE 5. STRONGPOINT AT GROUYNE 10

The decision to construct an experimental flexible, rockfill strong point in place of the updrift terminal groyne, No. 10, was taken to prevent loss of material from the groyne system during periodic severe reverse drift. At the same time it was intended to accumulate on the updrift side the smaller natural beach material, as, being in greater shelter from Hengistbury Head, it could be retained on the beach. The strong point, illustrated in Figure 5, was very successful and one year later, in 1973, a considerable beach had been built up and retained on the western, updrift side and this beach was gradually extending westward providing increasing protection to the clay undercliff and foreshore. In extending it was adopting the plan form of the down drift end of a crenelated bay. A larger strong point proposed at Chewton Bunny intended to form the updrift headland to this artificial bay has not been constructed to date due to private property and Authority boundary complications.

However, the indications of success in this simple approach to coast protection led to the construction of two more strong points in 1975. These were built as short armoured rock-rubble breakwaters, using the existing timber groynes 18 and 22 as protection against short term erosion on the down drift side. Figure 4 shows the position of these strong points and Figure 5 indicates their construction, following typical breakwater practice. Again toe protection, against the rock fill spreading under wave action, is provided by concrete Tripods of 2.2 tonnes each. These are a simple form of interlocking armour unit, developed by the Author's Firm, which are ideal for stabilising the toe of shallow water rock embankments.
