Lessons Re-Learnt from the Failure of Marine Structures

Dr Roger Maddrell, Consultant, Halcrow Group Ltd, Swindon, UK

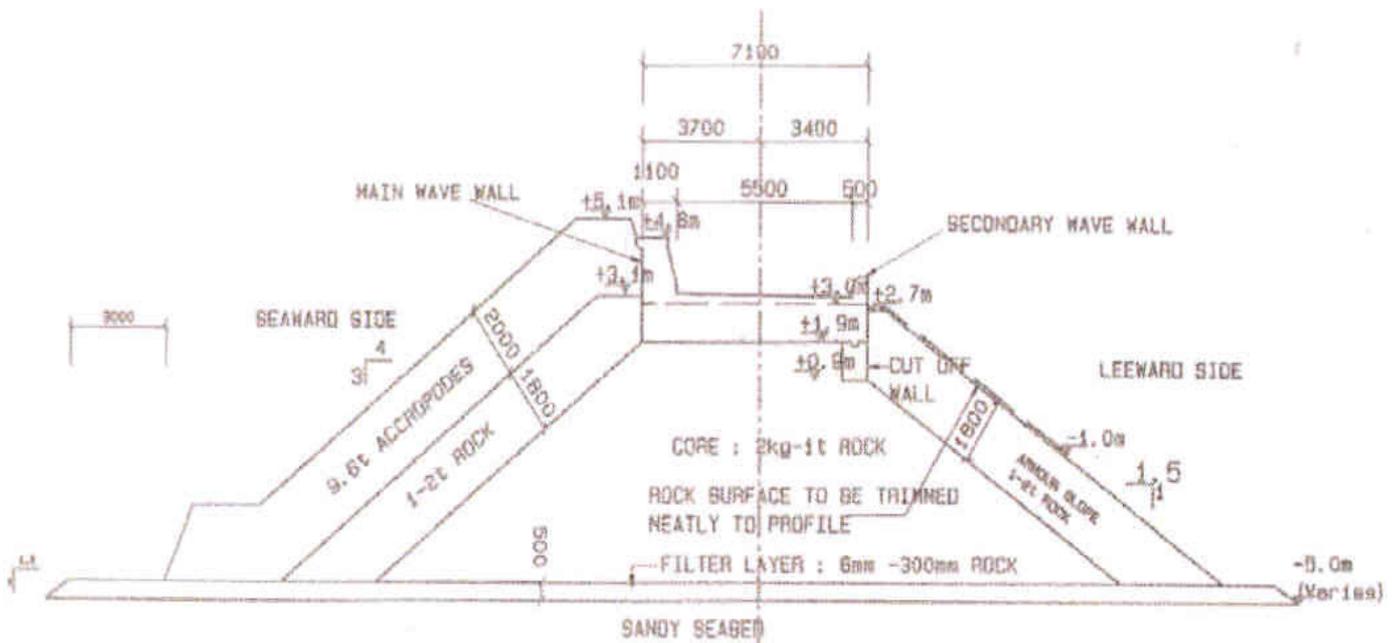
**Figure 1 Design Cross-section of the Club Mykonas Breakwater
(after Bartels et al, 2003)**

This breakwater was constructed in 1988 and was protected by 9.6t Accropodes (see Figure 1). However, by 1991 significant settlements to the armour layer was apparent (up to 3.5m), which included a movement away from the wave wall behind them (up to 1.5m). Surveys revealed that a 3.5m deep erosion hole had developed in 5m of water near to the landward end of the breakwater. The cross-sections for the breakwater shows the 9.5t Accropodes on a 1 in 1.33 slope (3 to 4) with the toe of the units resting on a 0.5m thick filter layer of 6mm to 300mm rock on the sand bed.

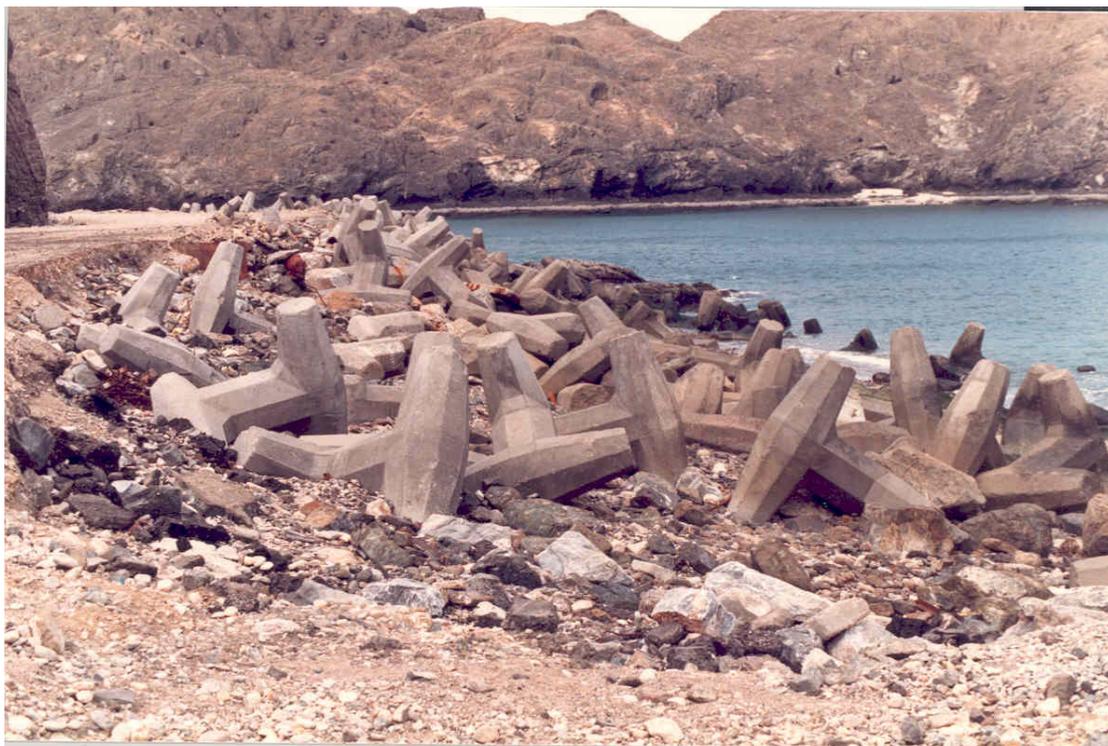
Photograph 1 The Jalali Dolosse revetment after the storm

The damage to the revetment, as can be seen on Photograph 1, was severe and, at the end of the storm, no part of the revetment consisting of two layers of 6t Dolosse units was left undamaged. Again, the storm does not appear to have particularly severe, with a predicted return period of 1 in 25 years, with the structure apparently designed to withstand a 1 in 100 storm.

The reason for the failure was not specifically because of the fragility of the Dolosse units, but the fact that the low crest level of the revetment allowed considerable overtopping, dislodging the Dolosse at the top of the slope, which were not retained in any way. The fact that the Dolosse were sitting on a toe of filter rock weighing on average 1.3kg, undoubtedly also contributed to the failure. For the reconstruction, heavy blocks were placed at the top of the slope and the revetment protected with Shed units, which sat on a concrete toe beam where rock was exposed and a piled concrete beam where the bed was sand. The latter was further protected with a rock armour apron. The heavy concrete blocks placed at the top of the slope were provided with large vents; some 200mm in diameter at 2m centres to resist the uplift forces (see the discussion by Read, 1985).

Lessons: Damage due to overtopping of any rubble mound structure can be severe and can lead to damage to the front face. Reinforcing concrete armour units is not recommended and it is essential to properly design the toe of any structure.

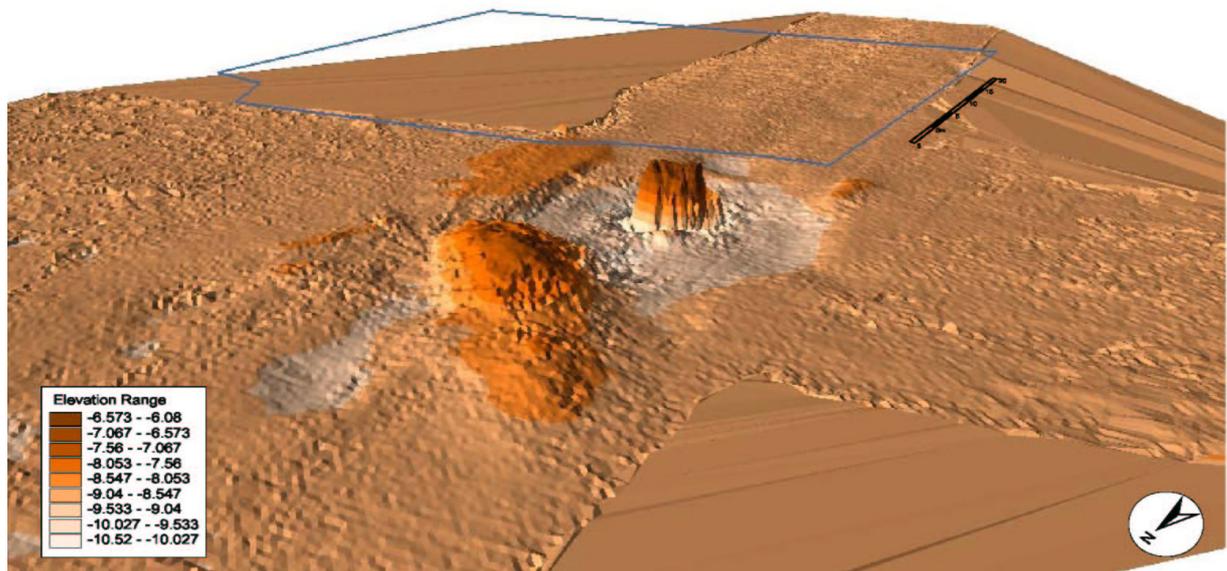
Figure 2 Scour and accretion around the outfall

The scour hole created was elliptical with the erosion being greater on the seaward side than the landward side. It should be noted that there were four ports on the seaward side discharging water at 3m/s at an angle of 20° to the horizontal. There was also accretion on the seaward side but, away from the structure, bed levels changed little.

The analysis of the design indicated that the amplification factor for the currents could be as much as 10, which would have been capable of moving the main armour rock. The area of erosion seen was very much as predicted and, despite the increase in the size of the filter rock during construction, it is unlikely that it would have remained stable. It would appear from subsequent model tests that it was the loss of scour rock both from the bed and through the underlayer rock that triggered the failure, along with the passage of sand through the filter rock. The increased turbulence from the outfall jets also appears to have had an impact as would any problems and difficulties during construction.

with the armour rock extending for about 1.5 times diameter of the outfall, was also tested on the model. Geotextile was also provided.

Lessons: Consideration must be given in the design to likely difficulties there will be in constructing the design and, if the exposed filter rock can be considered ‘sacrificial’, what will happen to the structure when it is eroded. Physical modelling of complex structures should be carried out.
